New York State Department of Transportation

Yellow Flag NB2258W020

BIN: 1065318

Feature Carried: 278I278IX2M23027

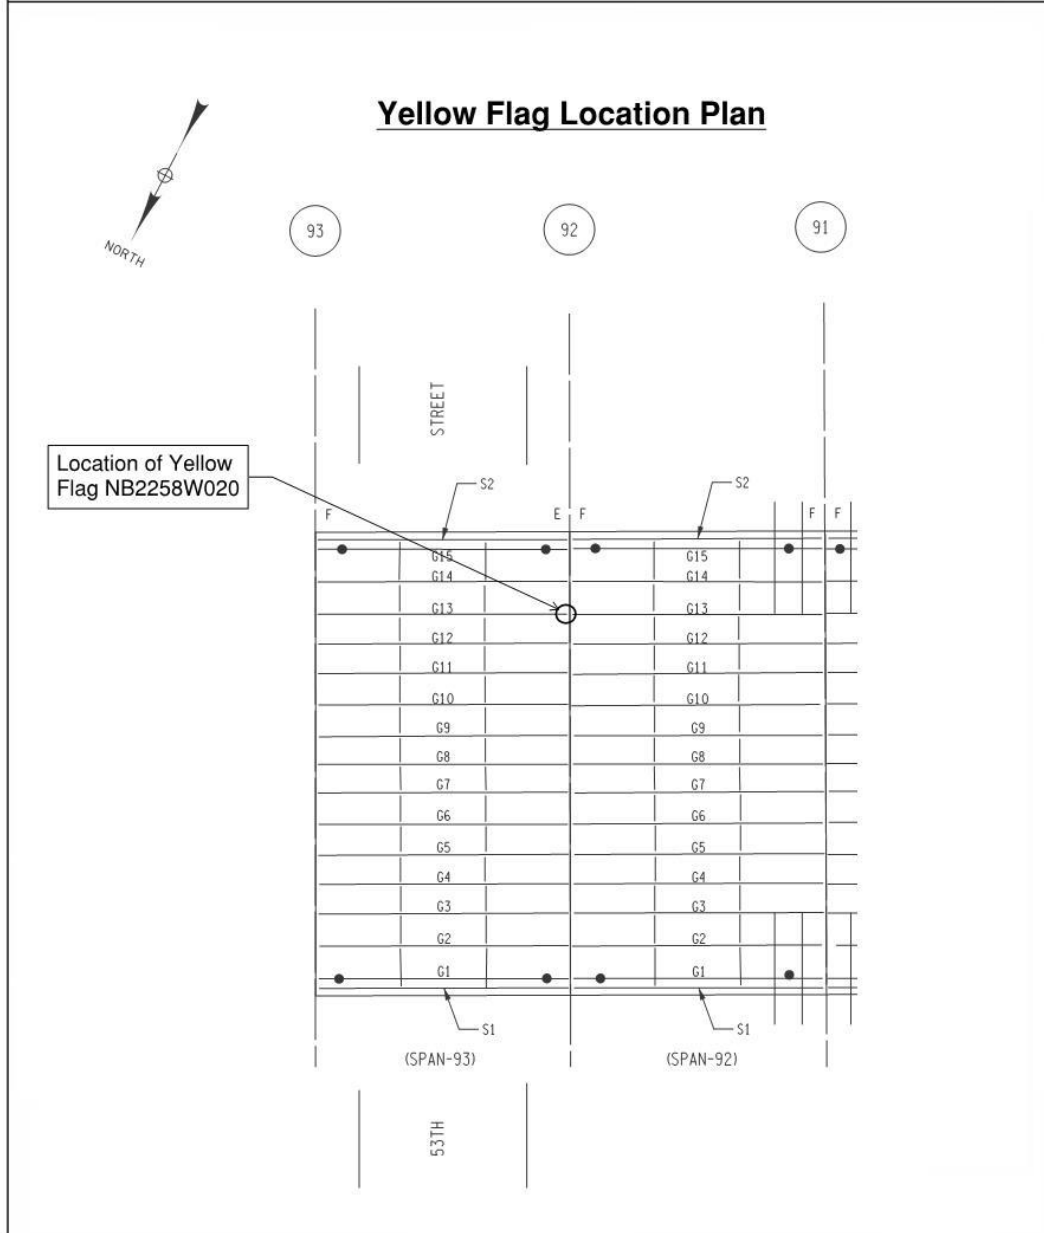
Flag PhotographsPhoto Number: **1**Photo Filename: **22_Flag Location Plan.jpg**Gowanus Expressway
2022 Biennial Inspection - Field SketchBIN: 1065318Team: AA/TSDate: 10/18/2022Span: 93Location: Bearing at G13 at Pier 92

**wsp****Attachment Description: Yellow Flag Location Plan**

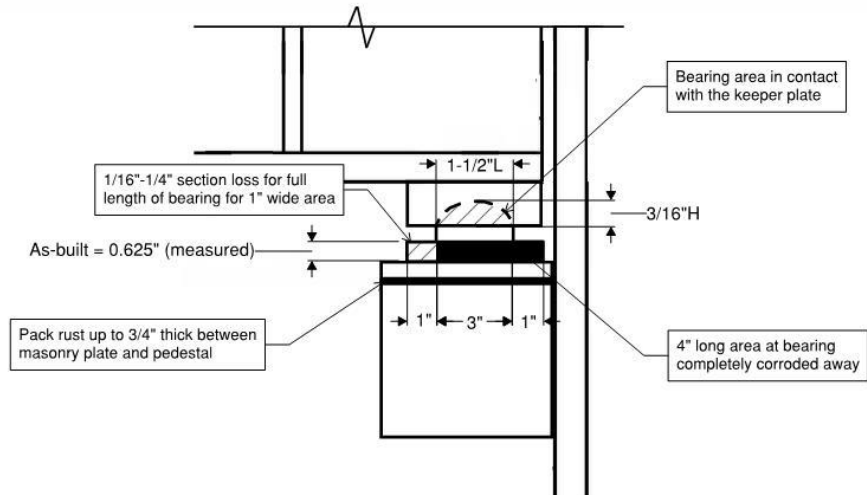
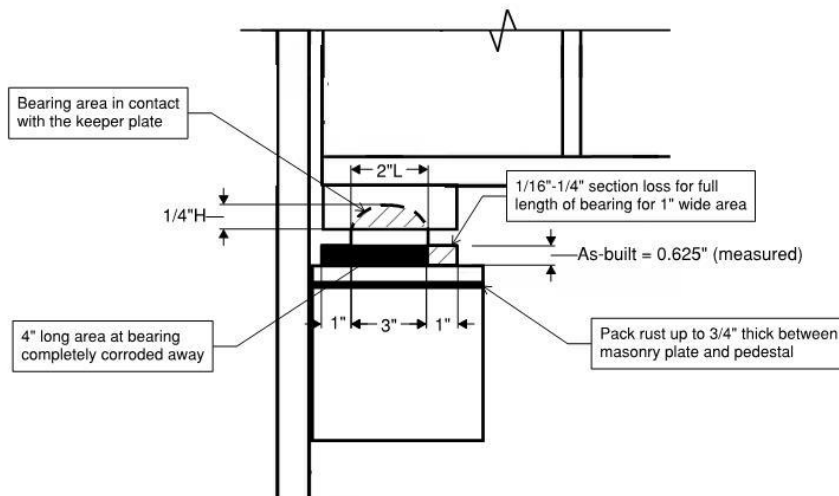
Photo Number: 2

The bearing under Girder G13 on Span 93 Side at Pier 92 exhibits severe section loss with the begin side leg of the bearing and middle portion of the bearing base completely corroded away and 1/16"-1/4" Remaining Thickness Measured (RTM) for full width of end side of leg of bearing resulting in approximately 60%-90% section loss (Photos 5 and 6). Due to the severe section loss, the bearing is tilted towards the begin side. Both sides of the bearing are in contact with the keeper plates for approximately 1/4" high over 2" long area at the left side and approximately 3/16" high over 1-1/2" long area at the right side (Photos 8 and 9). Both guide plates are completely corroded away. The masonry plate exhibits pack rust up to 3/4" thick between top of pedestal (Photo 7). The pedestal below bearing exhibits no significant defects (Photo 4). The girder on Span 92 side of pier is framed into cap-beam and exhibits no significant defects. (refer to Yellow Flag Condition Sketch Photo #2 for more details)

Attachment Description: Yellow Flag Condition Sketch

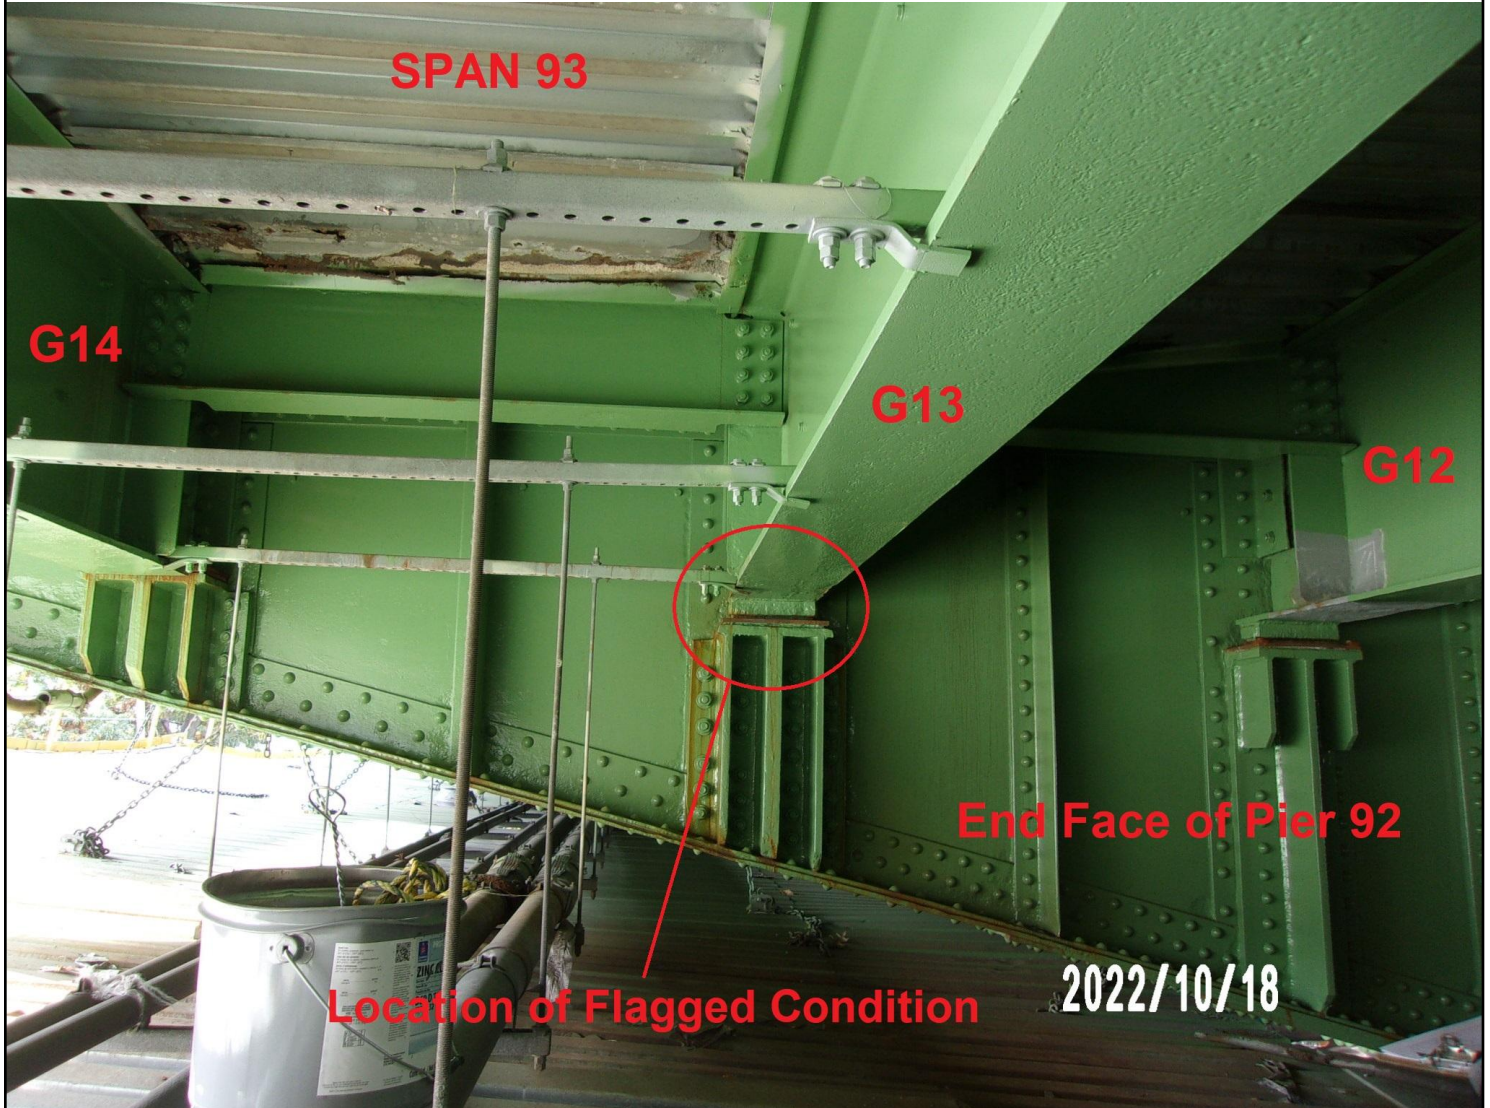
Photo Number: 3

Attachment Description: General view of the flagged condition at the bearing under Girder G13 in Span 93 at Pier 92. Looking Begin.

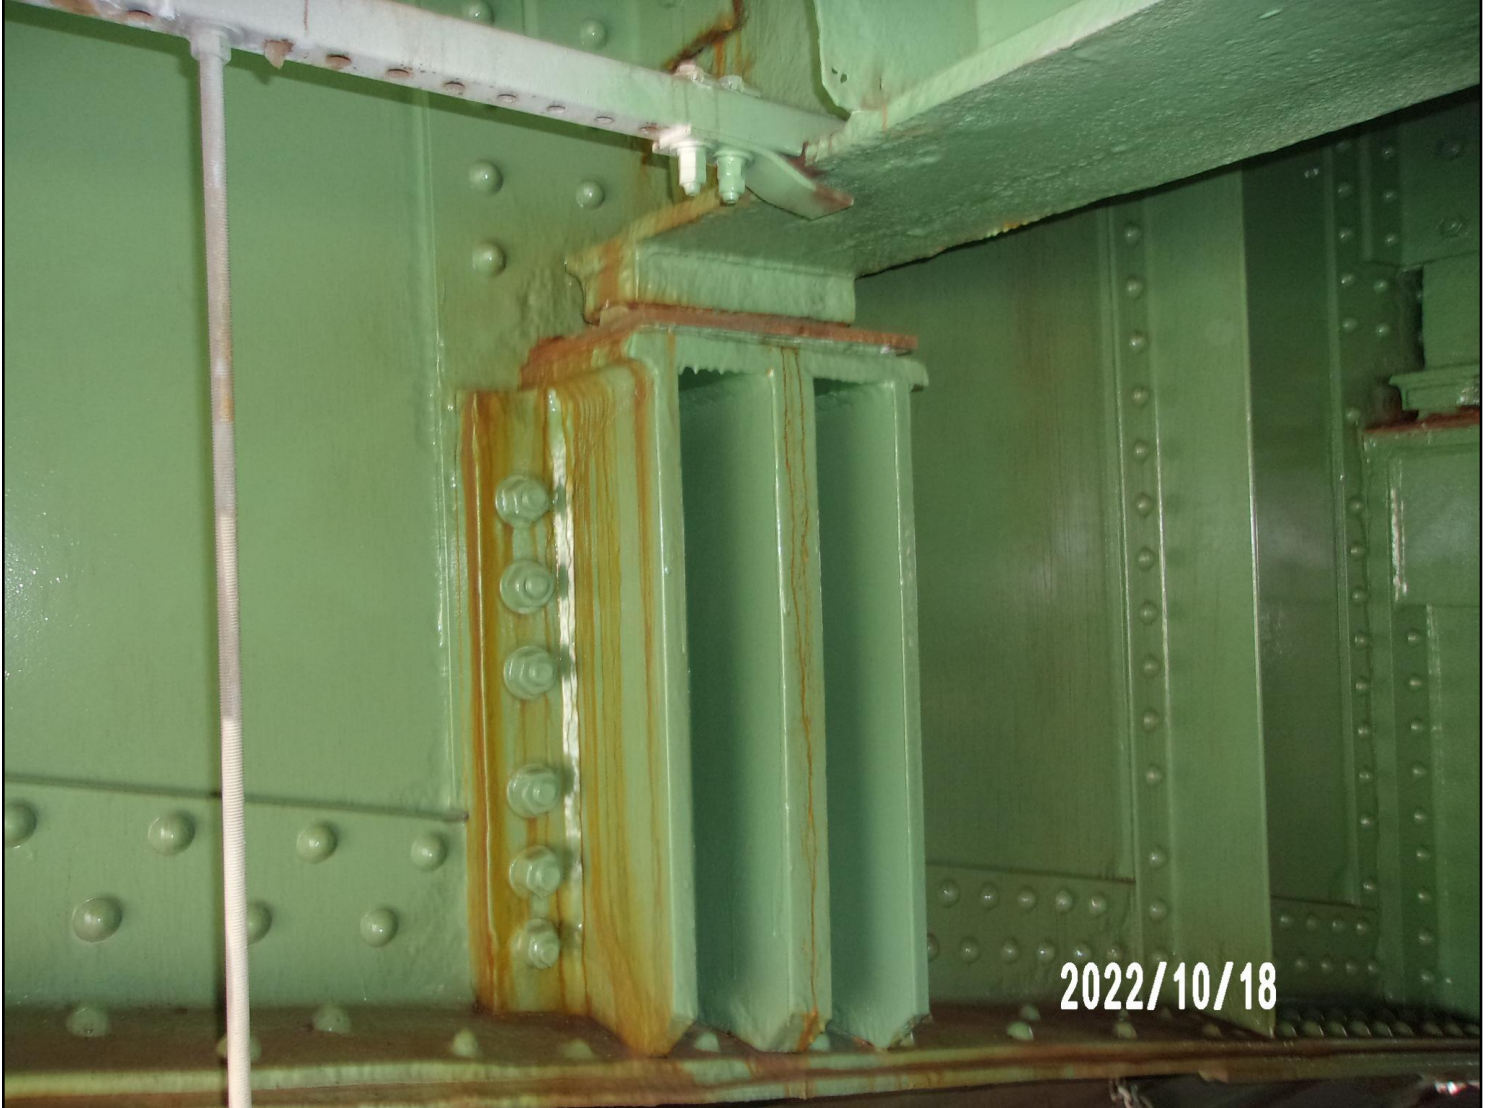
Photo Number: 4

Attachment Description: Close up general view of the bearing under Girder G13 in Span 93 at Pier 92. The pedestal under the bearing exhibits no significant defects. Looking Begin and Left.

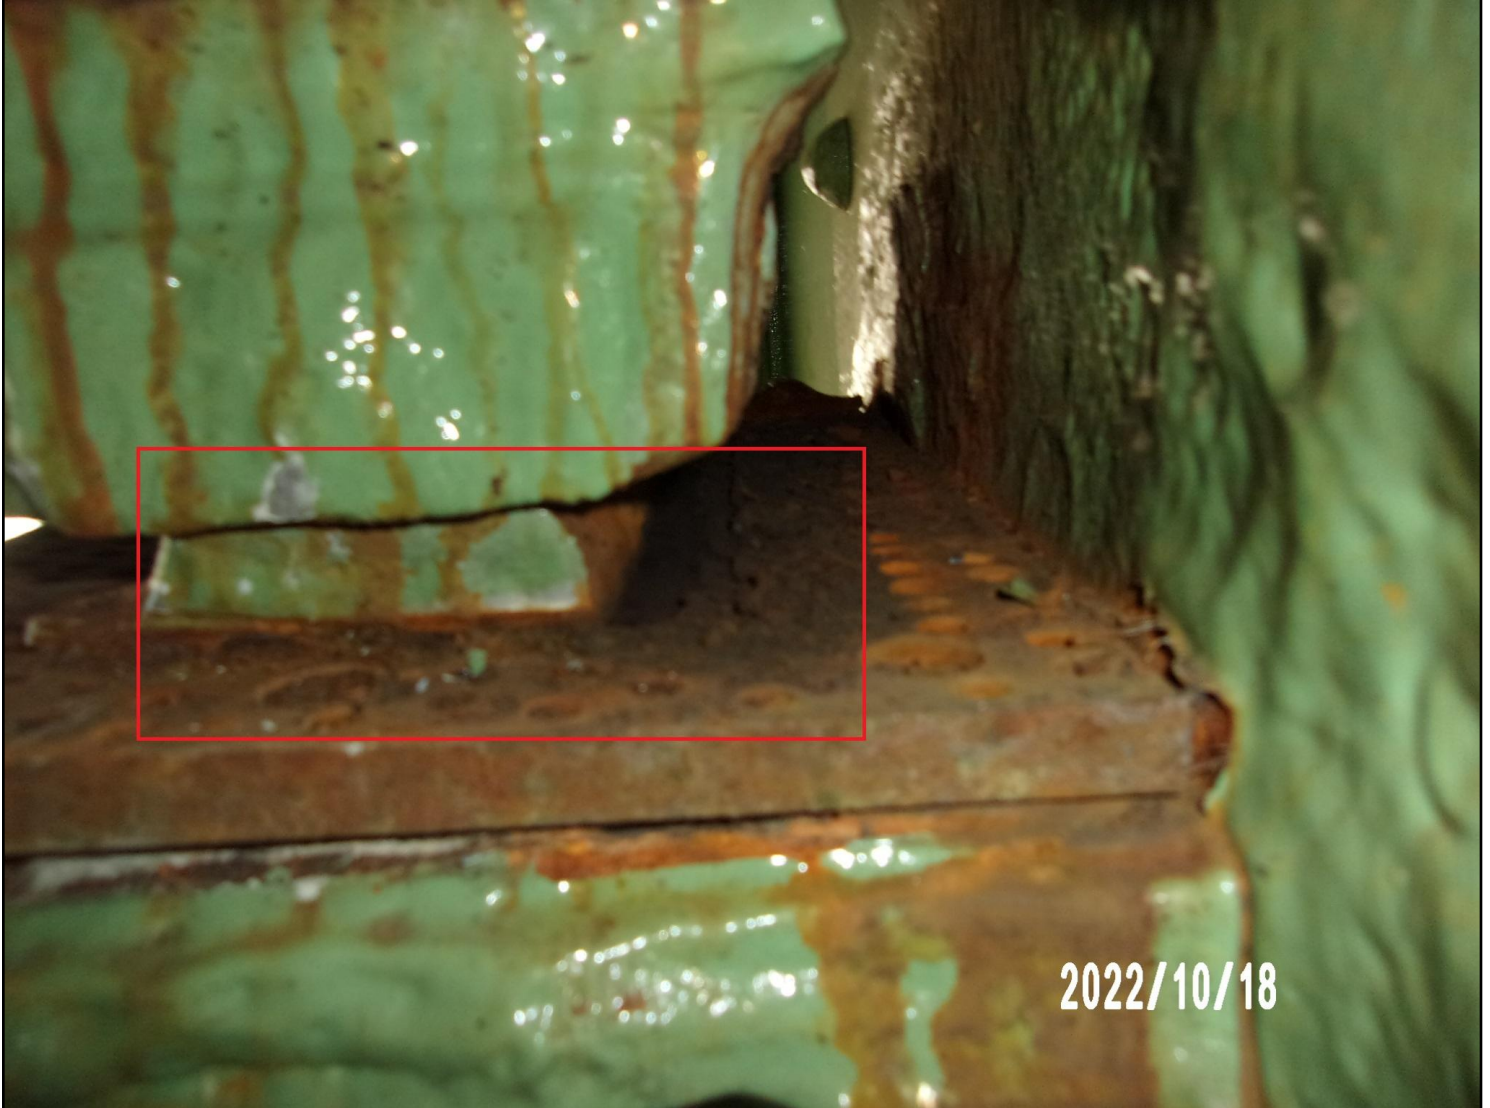
Photo Number: 5

Attachment Description: The left face of the bearing under Girder G13 on Span 93 side of Pier 92. The begin side leg of the bearing and middle portion of the bearing base is completely corroded away. Looking Right.

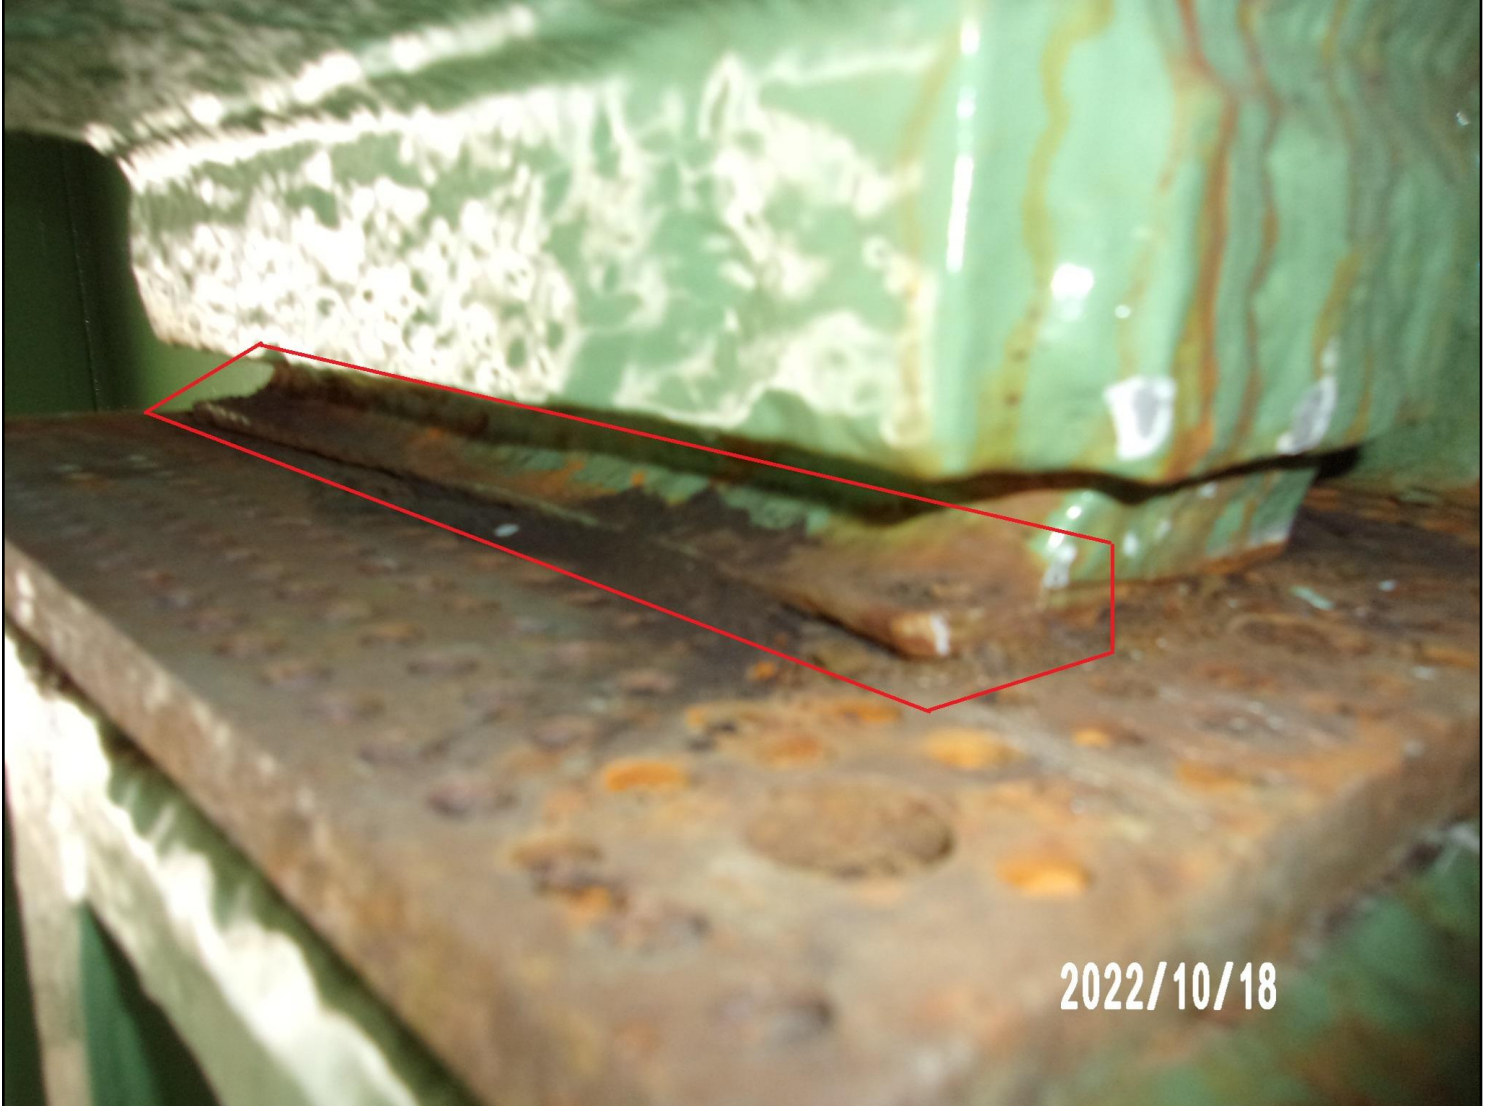
Photo Number: 6

Attachment Description: The end face of the bearing under Girder G13 on Span 93 side of Pier 92. The end side leg of the bearing exhibits 1/16"-1/4" RTM (approximately 60%-90% section loss) for the full length of the bearing for 1" wide. Looking Begin and Right.

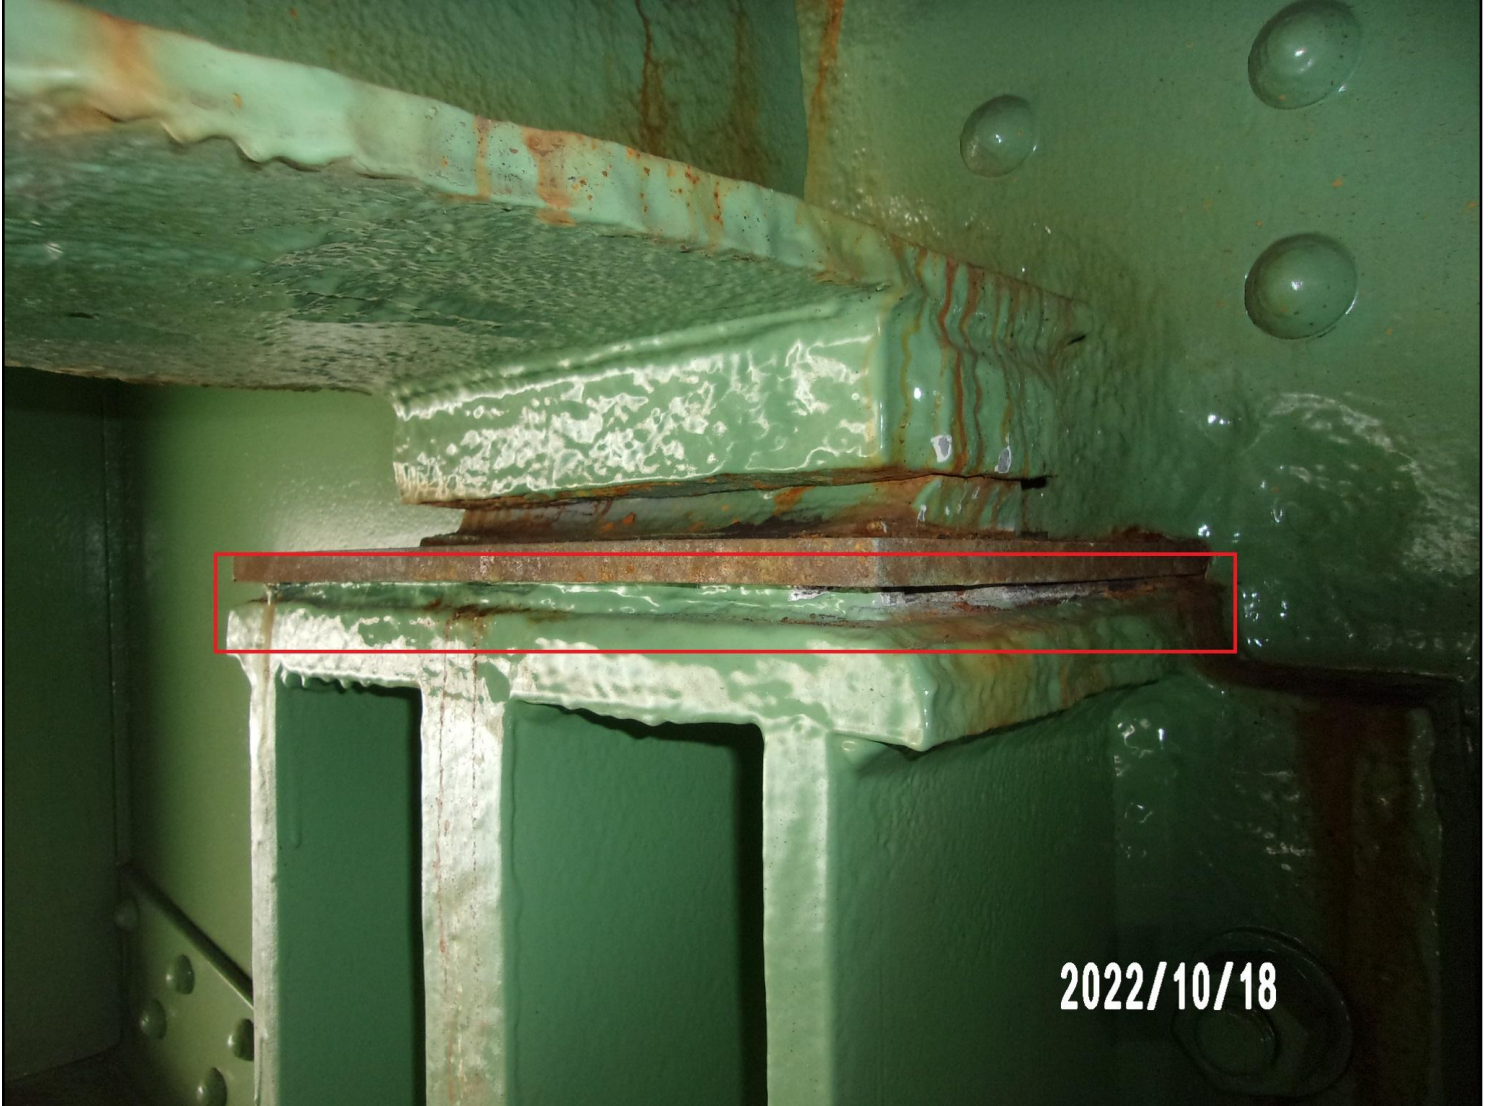
Photo Number: 7

Attachment Description: The end face of the bearing under Girder G13 on Span 93 side of Pier 92. There is pack rust up to 3/4" thick between the masonry plate and the top of the pedestal. Looking Begin and Right.

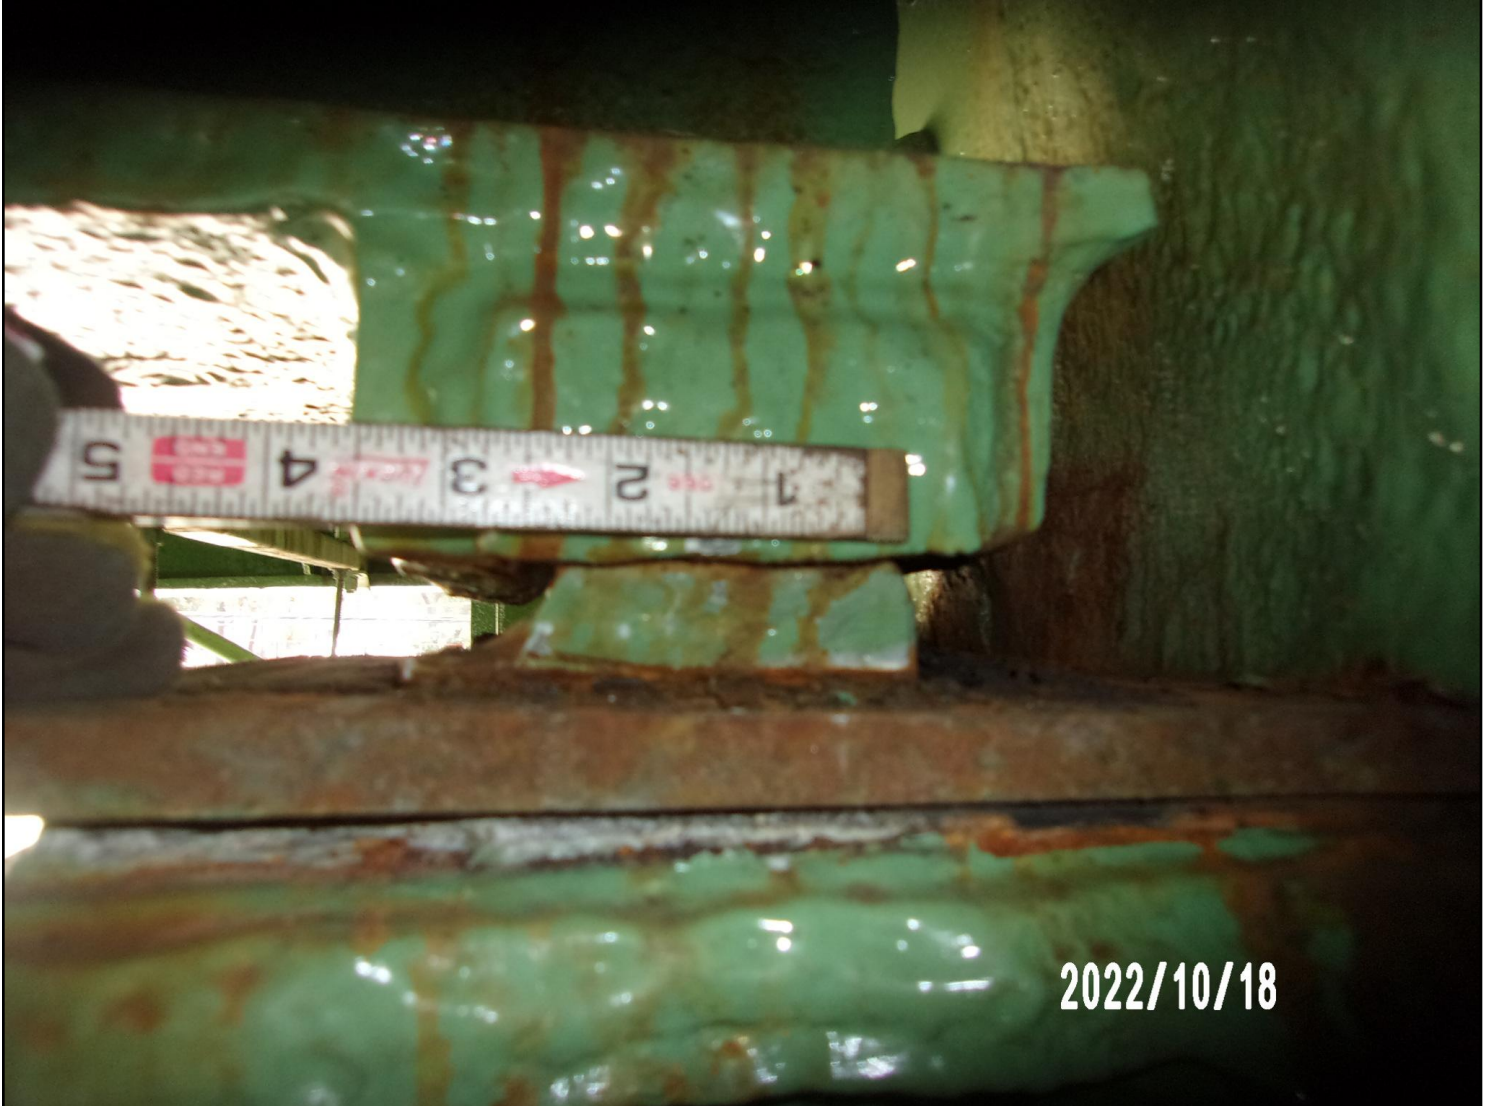
Photo Number: 8

Attachment Description: The left face of the bearing under Girder G13 on Span 93 side of Pier 92. Due to the severe section loss, the bearing is tilted towards the begin side with top of bearing in contact with the keeper plate for 1/4" high over 2" long area at the left side. Also, the guide plate at the bearing is completely corroded away. Looking Right.

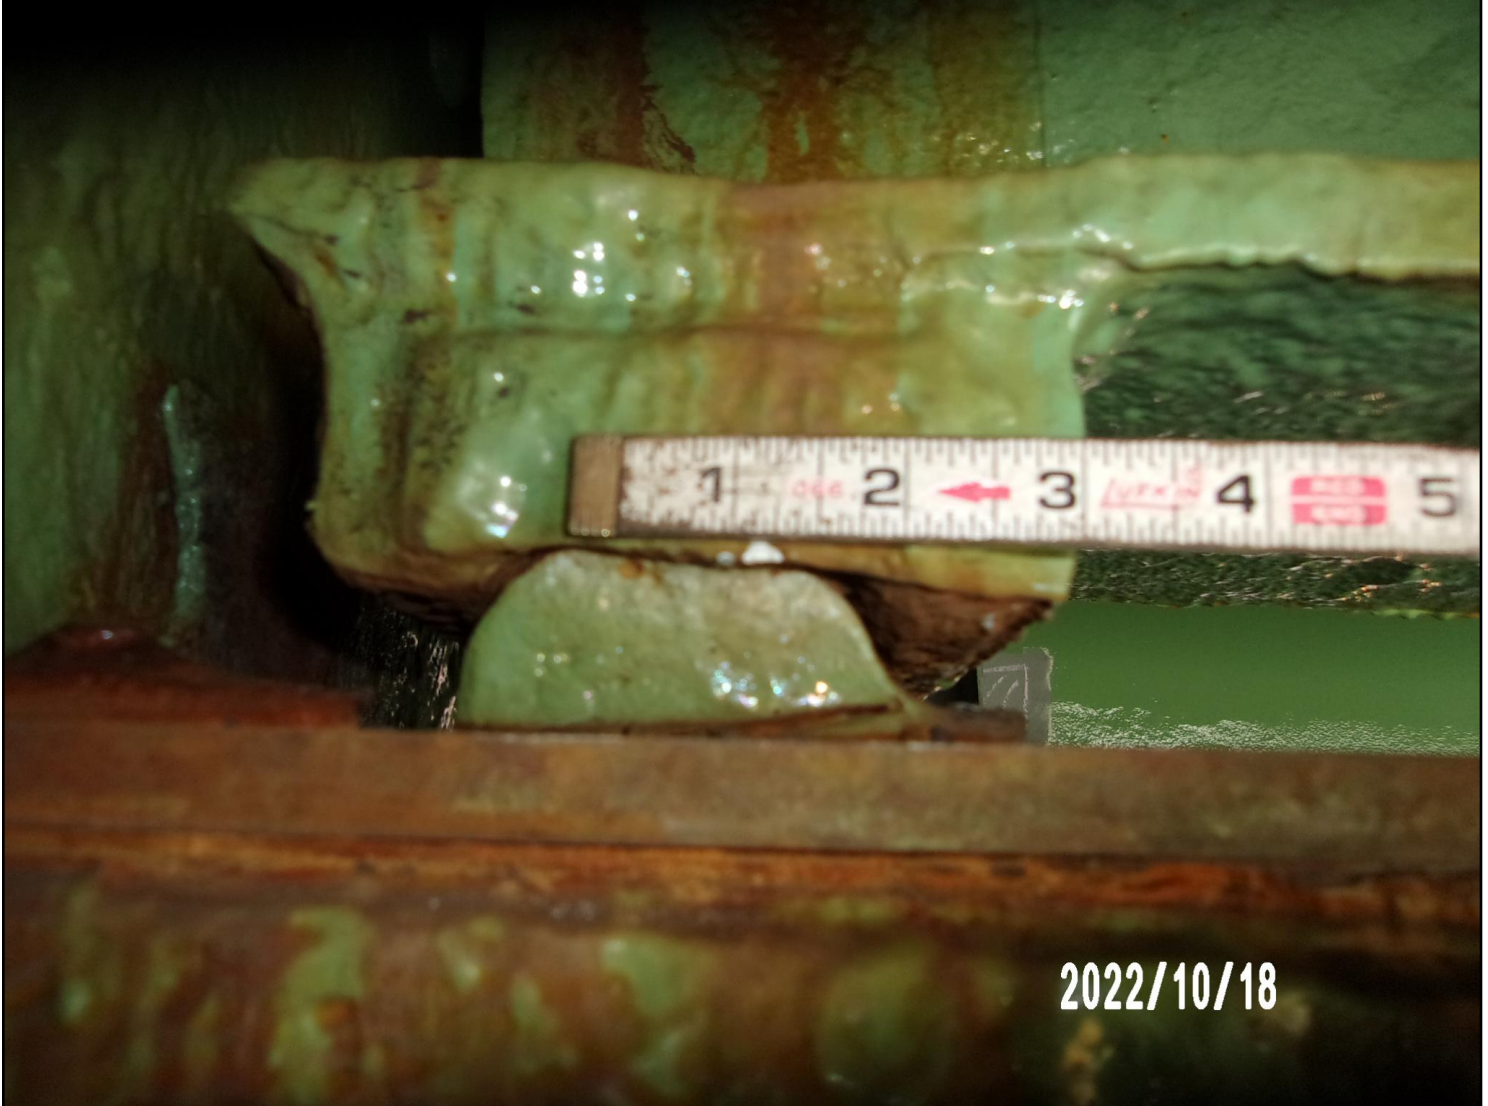
Photo Number: 9

Attachment Description: The right face of the bearing under Girder G13 on Span 93 side of Pier 92. Due to the severe section loss, the bearing is tilted towards the begin side with top of bearing in contact with the keeper plate for 3/16" high over 1-1/2" long area at the right side. Also, the guide plate at the bearing is completely corroded away. Looking Left.

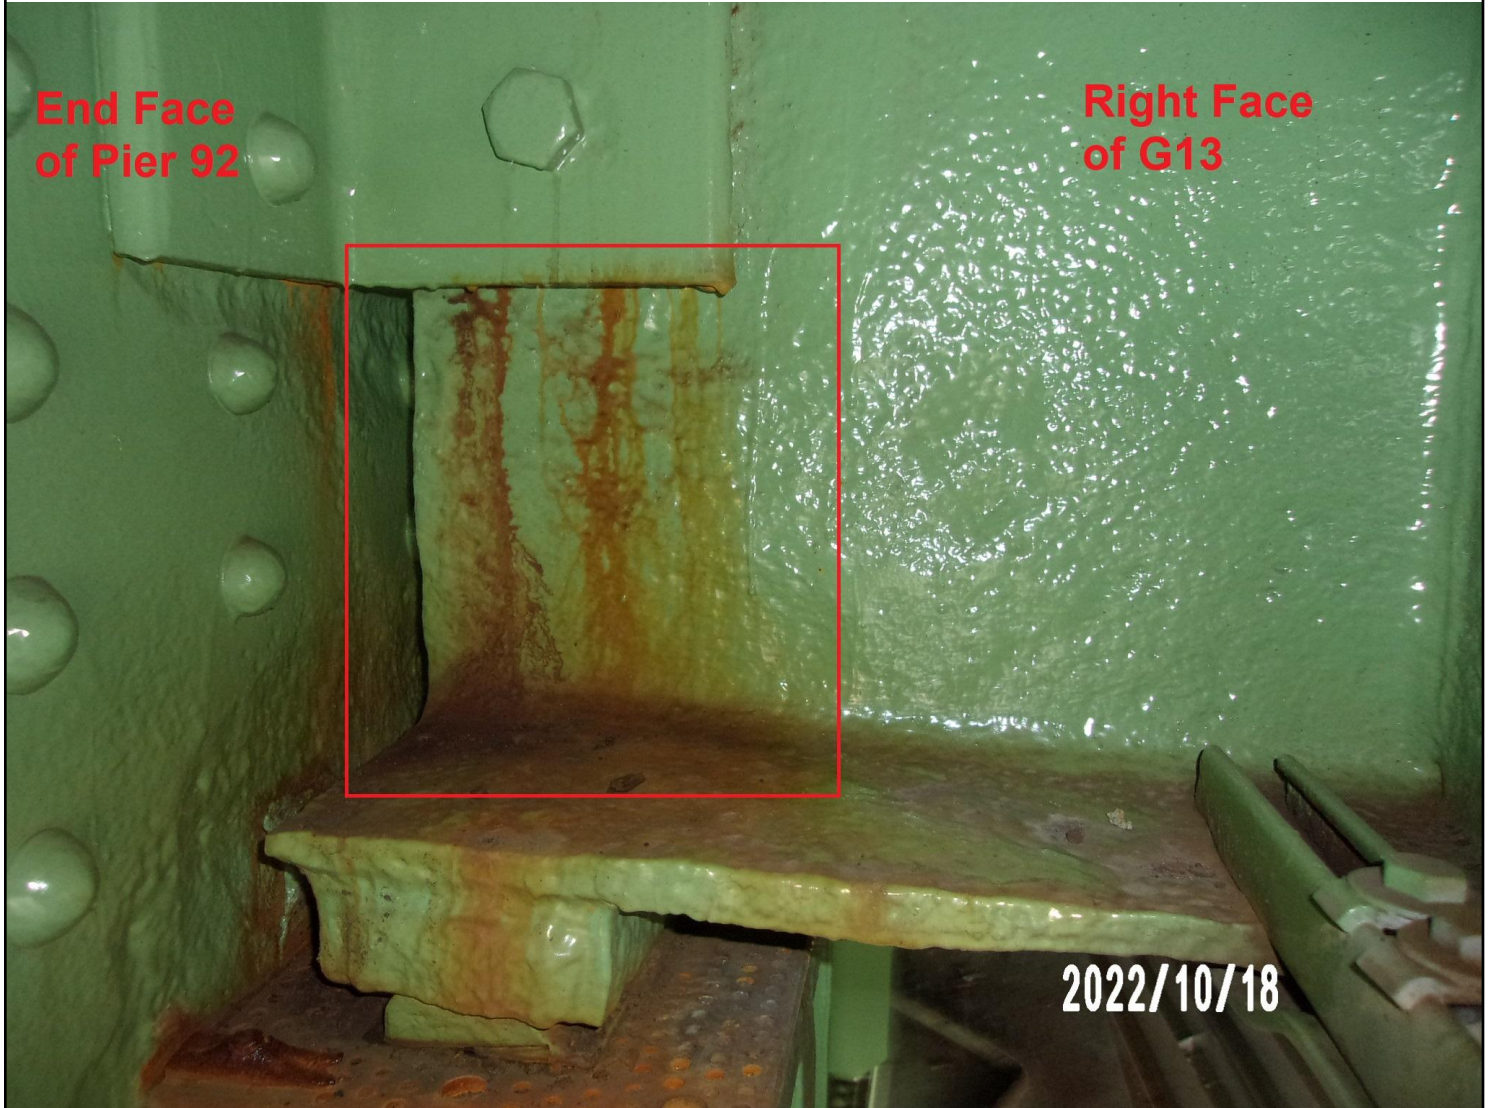
Photo Number: 10

1. The girder end above the bearing exhibits 40% section loss (3/8" RTM) in the web area above the bearing and for the full web height along the guide angle with 70% section loss (3/16" RTM) in the upper web adjacent to the end side of the top cope with 4" high x 5" long corrosion hole in the upper web. The overall shear web area section loss is 40%. (Photos 10 thru 12).

Attachment Description: The right face of Girder G13 in Span 93 at Pier 92. The web area above the bearing exhibits 40% section loss. Looking Left.

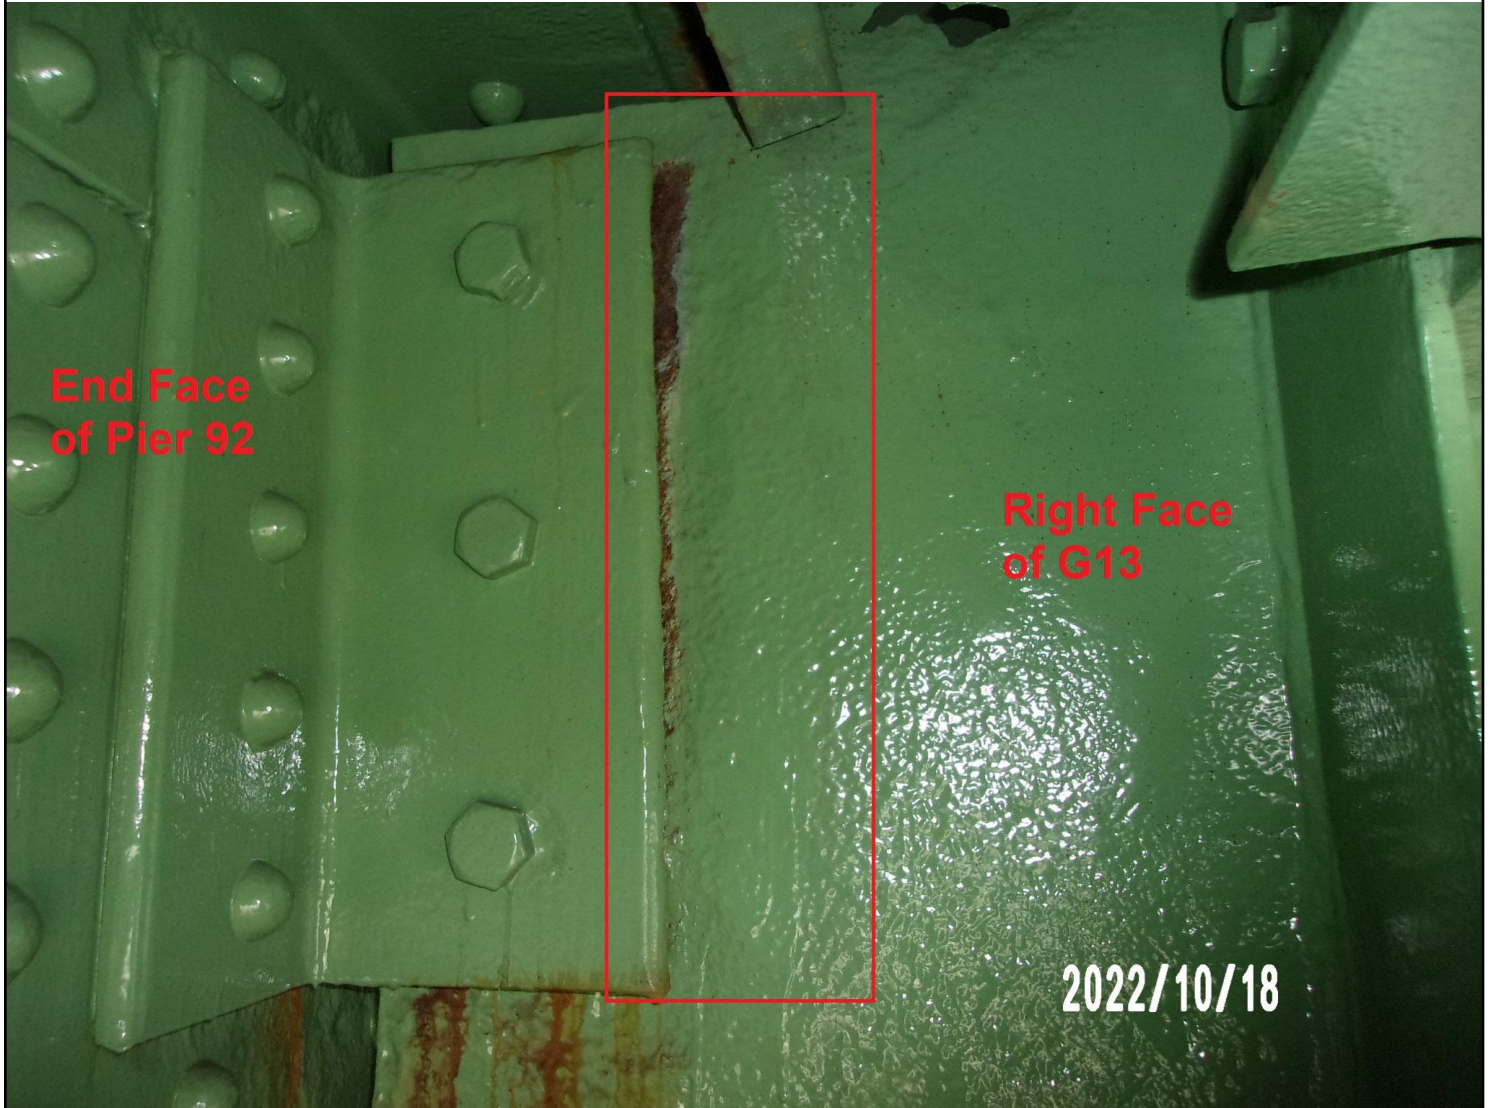
Photo Number: 11

Attachment Description: The right face of Girder G13 in Span 93 at Pier 92. The full height of the web along the guide angle exhibits 40% section loss. Looking Left.

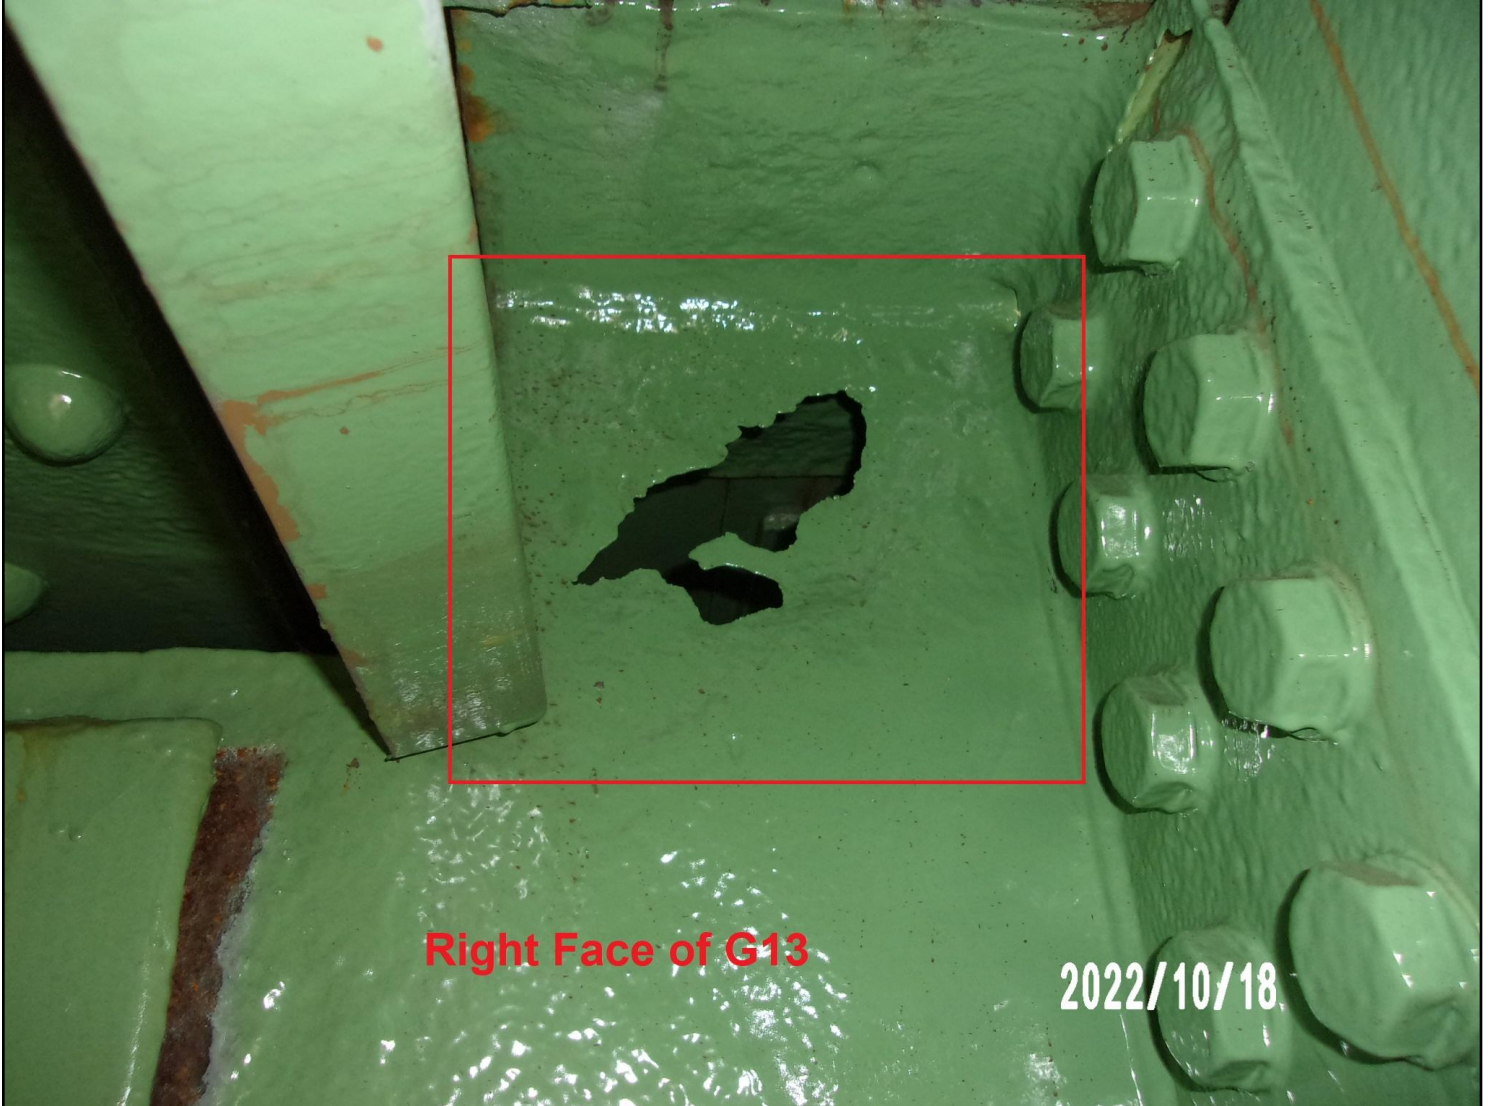
Photo Number: 12

Attachment Description: The right face of Girder G13 in Span 93 at Pier 92. The upper web of the girder adjacent to the end side of the top cope exhibits 70% section loss with corrosion hole in the upper web. Looking Left.
